Effect of long-term exposure and delayed drying time on moisture and mechanical integrity of flooded homes

H. Aglan¹, A. Ludwick¹, S. Kitchens², T. Amburgey², S. Diehl² and H. Borazjani²

¹ College of Engineering, Tuskegee University, Tuskegee, AL, USA

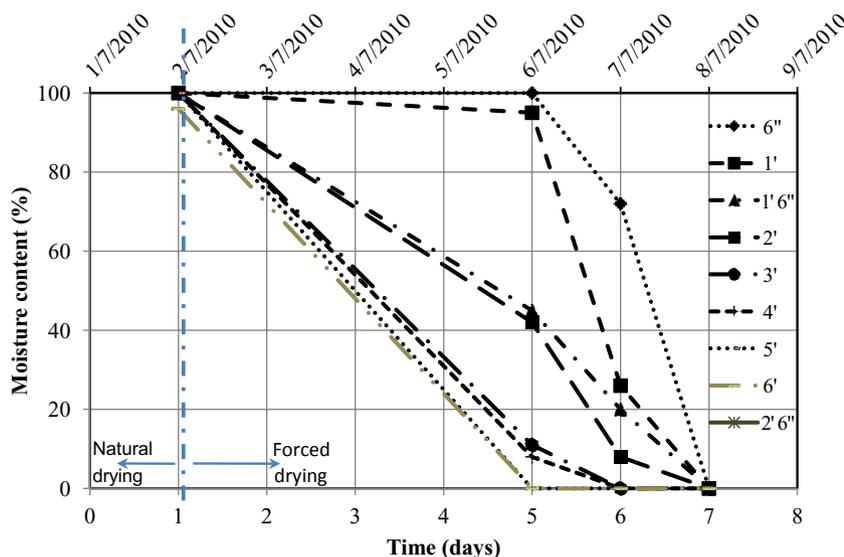
The north wall measurements clearly show the effect of natural drying versus forced drying (Table 1). For 11 days of natural drying, all moisture content measurements were

100% up to a height of 5 ft 6 in. (1.68 m) from the floor. This indicates that the walls to this height were fully saturated with water. By the 15th day of drying, representing 4 days of forced drying conditions, only the heights of 6 in. (152.4 mm) and 1 ft (304.8 mm) from the floor still had a 100% and 95% moisture content, respectively. However, they dried precipitously during the fifth and sixth day of forced drying (see Figure 5). All other heights from the floor showed a sharp, linear decrease in moisture content throughout the period of forced drying (Figure 5).

Figure 5 Moisture content in the flood unit north wall gypsum board during natural and forced drying after exposure to flood water (zero moisture content represents as received dry wall; 100% represents full saturation).

Thus, it can be seen that natural drying is not an effective drying method for long-term flooding. Forced drying should be started as soon as possible after re-entry in order to minimise water damage to building materials.

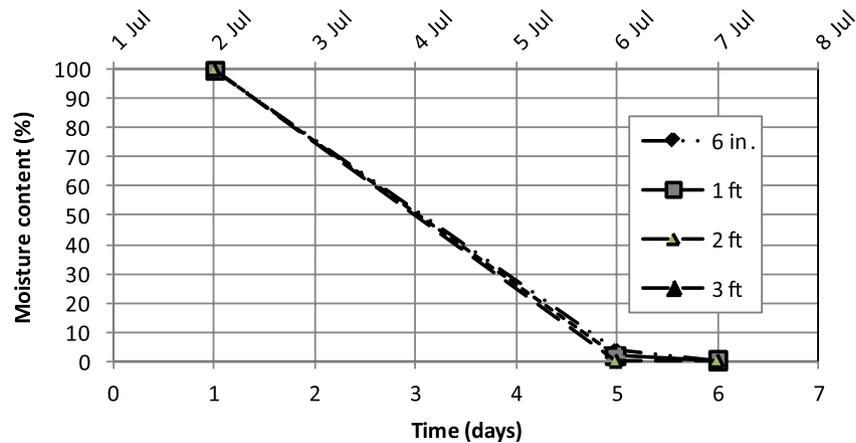
measurements were about 100% up to a height of about 5 ft (1.52 m) from the floor. The natural drying of the south wall was slightly more effective than the natural drying of the north wall. By the 11th day, when natural drying ended and forced drying began, the gypsum board of the south wall was still saturated with water. At 5 ft 6 in., the moisture content of the south wall was 99%. The effect of the forced drying of the FU also varied from the north to the south walls. Except for low levels of moisture content at the 6 in. (152.4 mm) and 1 ft (304.8 mm) levels from the floor, the south wall was dry within 4 days of forced drying (Figure 6 and Table 2). The north wall required nearly 7 days of forced drying to dry

completely. The greater sun exposure of the south wall probably contributed to this faster drying rate of the south wall.

Figure 6 Moisture content in the flood unit south wall gypsum board during natural and forced drying after exposure to flood water (zero moisture content represents as received dry wall; 100% represents full saturation).

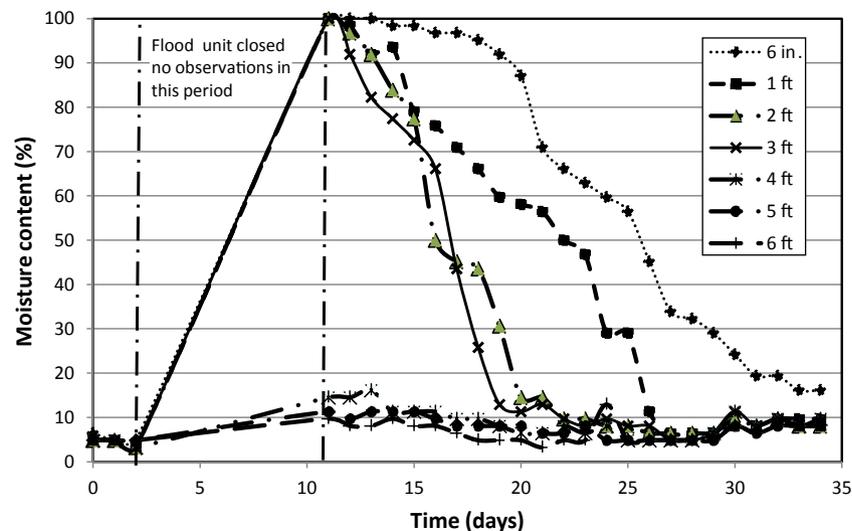
Figure 7 Moisture content versus time for the gypsum board on the south wall of the short-term exposure study. Day 2 is the beginning of flooding, day 5 is the draining of the basin, day 10 is the re-entry into the module and the beginning of observation and measurement and day 33 is the end of the drying period.

In the short-term exposure study (Aglan *et al.*, 2005), the FU was exposed to water for a considerably shorter time (three days) and opened 5 days later. Drying of the short-term study, FU was done entirely naturally (Figure 7). Day 21 of Figure 7 would be comparable with the time when forced drying was begun in the current long-term exposure study, 2 July in Figure 6. Clearly, a significant degree of drying had occurred naturally in the short-term study by that time, in contrast to the observations for the current long-period (3 weeks) flooding study. Moisture contents at the 6 in. (152.4 mm) and 1 ft (304.8 mm) height from the floor of the short-term flooded unit were still high at day 21. It took the bottom of the wall, 6 in. (152.4 mm) from the floor, almost 25 days from re-entry to dry naturally, as

shown in Figure 7. This indicates that forced drying is recommended for both short- and long-term flood exposure of buildings. The sooner the forced drying starts, the faster the water is removed from wet walls. This will expedite the restoration and can save some of the building components of flooded homes, allowing faster return of home owners.

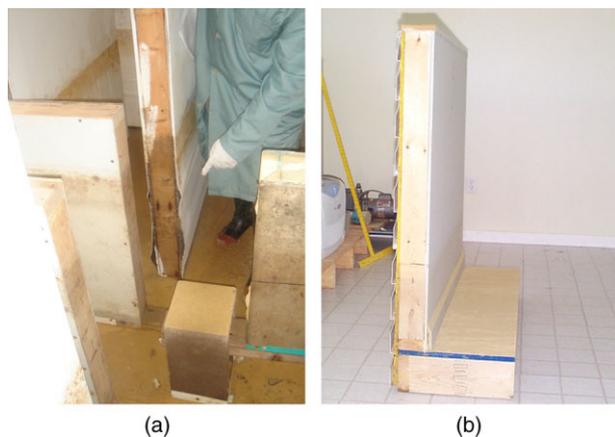
The effect of delaying the re-entry time has a major impact on the general appearance of the interior of FUs. This is manifested in severe mould growth and stain on the gypsum board walls of the long-time re-entry delay, 3 weeks versus 5 days. In addition, severe blistering of the paper face of the gypsum board is associated with the long-term delay. This was not the case for the short re-entry delay.

Figure 8 Effect of flooding period exposure on wall section test samples: (a) long-term flooding (3 weeks) and (b) short-term flooding (3 days).

The stark difference in the effect of long-term and short-term flooding on gypsum board can be seen in Figures 8–10. The test samples that were replicates of the interior walls (Figure 2) were exposed to long-term flooding (3 weeks), as described in the Materials and methods section. Figure 8(a) illustrates the effect of exposure to long-term flooding on the test samples that were replicates of interior walls (Figure 2). The swelling and peeling of the paper from the gypsum board of these test samples can be seen in Figure 8(a). The integrity of these samples has clearly been diminished, particularly below the water line. It is clear from Figure 8(a) that long-term exposure to moisture has weakened the adhesion of the outer paper face to the gypsum. This, in turn, can weaken the strength of the composite gypsum board. It is

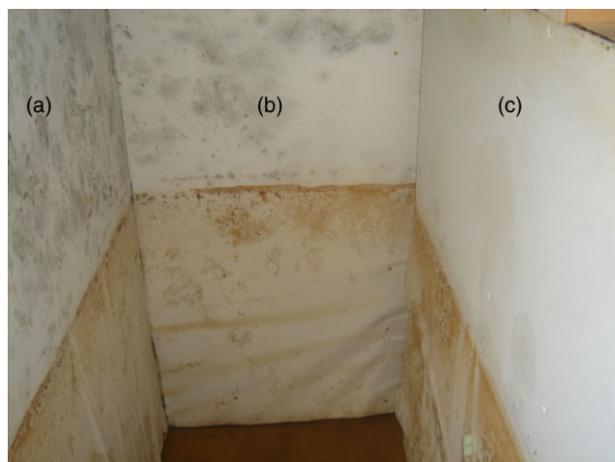
Figure 9 Effect of long-term (3 weeks) flooding on two walls; (a) south and (b) west of the flood unit and (c) one test sample.

The gypsum board of the exterior walls of the FU for the long-term flooding study was also examined. Figure 9 shows two of these exterior walls (south and west walls) as well as a test sample (right wall of Figure 9). Significant mould is seen on the walls, especially on the exterior walls of the FU. The swelling of the gypsum board and the delamination of the paper face of the gypsum board can clearly be seen for both exterior walls and the test sample.

Because there was significant delamination of the face paper of the gypsum board for the long-term flooding exposure (Figures 8(a) and 9), it was decided to evaluate the flexural strength of the core gypsum below and above the water line (Table 3). This delamination of the paper was not seen for the short-term FU (Figure 10). Table 3 shows the results of the flexural strength of gypsum board walls for both the long- and short-term flooding studies. The core gypsum for the long-term flooding exposure has not been affected significantly. There is a reduction of 8.5% below the water line and 5.1% above the water line with respect to the 'as received' sample.

- The integrity of the composite gypsum wallboard was generally damaged upon long-term (3 weeks) flooding, rendering it not useable. Thus, it may be beneficial in flood-prone zones to orient gypsum board sheets (typically 4 ft × 8 ft (1.22 m × 2.44 m)) horizontally rather than vertically. For flooding height of less than 4 ft (1.22 m) from floor level, only removing the bottom sheets of the gypsum board would be needed for restoration of flooded homes.

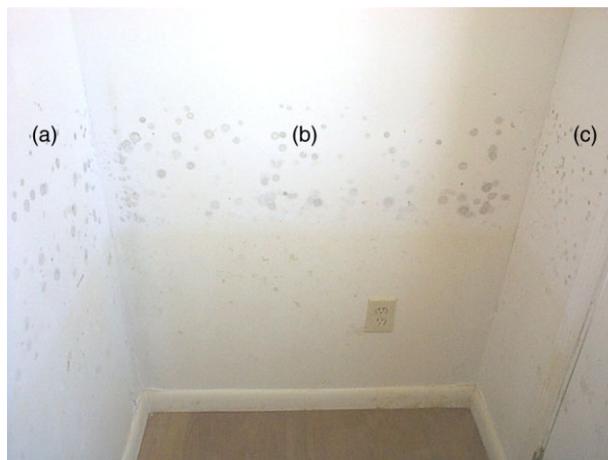
Figure 10 Effect of short-term (3 days) flooding on three walls: (a) south exterior, (b) west exterior and (c) interior wall (Aglan *et al.* 2005).

Figure 10 is a view for the short-term flooding (3 days) and 5 days of delaying re-entry taken at the same location as in Figure 9 (Aglan *et al.* 2005). Only very isolated portions of paint peeling was observed. Slight staining is visible below the water line. Additionally, mould is visible above the water line. However, no significant damage is seen to the gypsum board in Figure 10 (3 days of flood exposure) that could not be remediated by simple cleaning and repainting. In fact, the FU of this short-term flooding study was remediated and restored to its original condition with minimal effort (Aglan *et al.* 2005). On the other hand, the gypsum wallboard with the long-term flooding exposure FU is not repairable because the face paper of the gypsum composite has been detached.
