Effect of long-term exposure and delayed drying time on moisture and mechanical integrity of flooded homes

H. Aglan¹, A. Ludwick¹, S. Kitchens², T. Amburgey², S. Diehl² and H. Borazjani²

¹ College of Engineering, Tuskegee University, Tuskegee, AL, USA

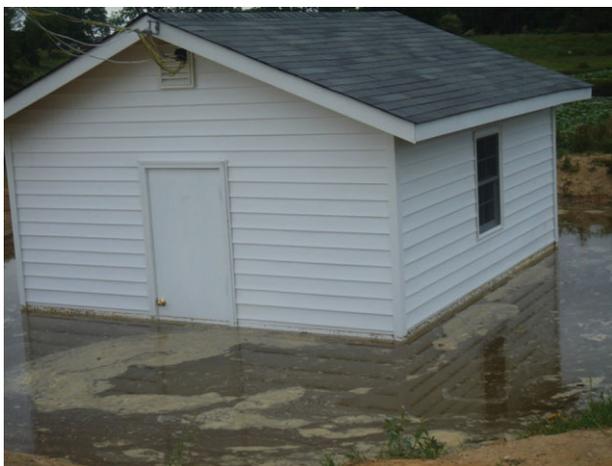
Figure 3 Flood unit submerged up to 2 ft (0.61 m) of water for 3 weeks during flood testing.

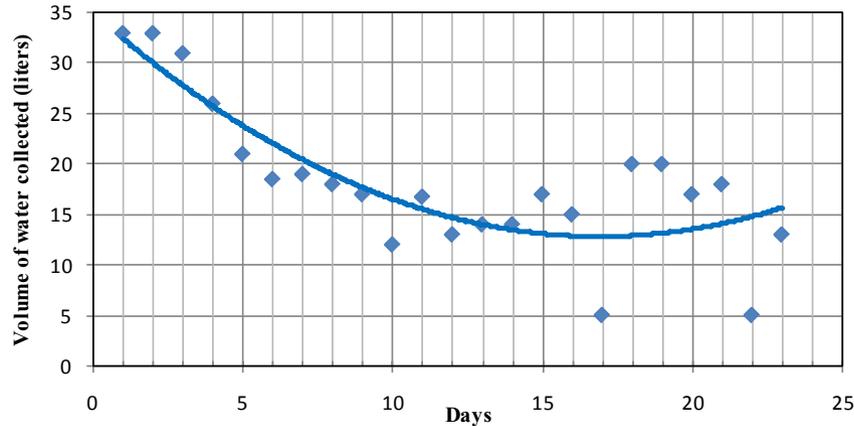
Measurements of the water removed from the FU by forced drying are shown in Figure 4. This represented the amount of water collected daily by the dehumidifier. As can be seen (Figure 4), the moisture removal occurs in two zones; up to about day 15, the collected moisture decreased with time. After that, a plateau was reached. The water collected after day 15 appears to be from the dehumidification

Figure 4 Volume of water removed from the flood unit during dehumidification and air conditioning.

of the air of the FU as the moisture content of all walls and ceiling reached the preflooding value. Zero moisture content represents as received dry wall; 100% represents full saturation. Some scatter in the volume of water collected at the end of the drying period is observed in Figure 4. This was due to a combination of rain, which artificially increased the amount of water collected and power failure due to storms, which artificially decreased the amount of water collected.

Thus, it can be seen that natural drying is not an effective drying method for long-term flooding. Forced drying should be started as soon as possible after re-entry in order to minimise water damage to building materials.
